File No. 722-42

Docket No. SA-59

REPORT OF THE CIVIL AERONAUTICS BOARD

On the investigation of an accident involving aircraft of United States registry NC 21788 which occurred at Detroit City Airport, Detroit, Michigan, on March 2, 1942.

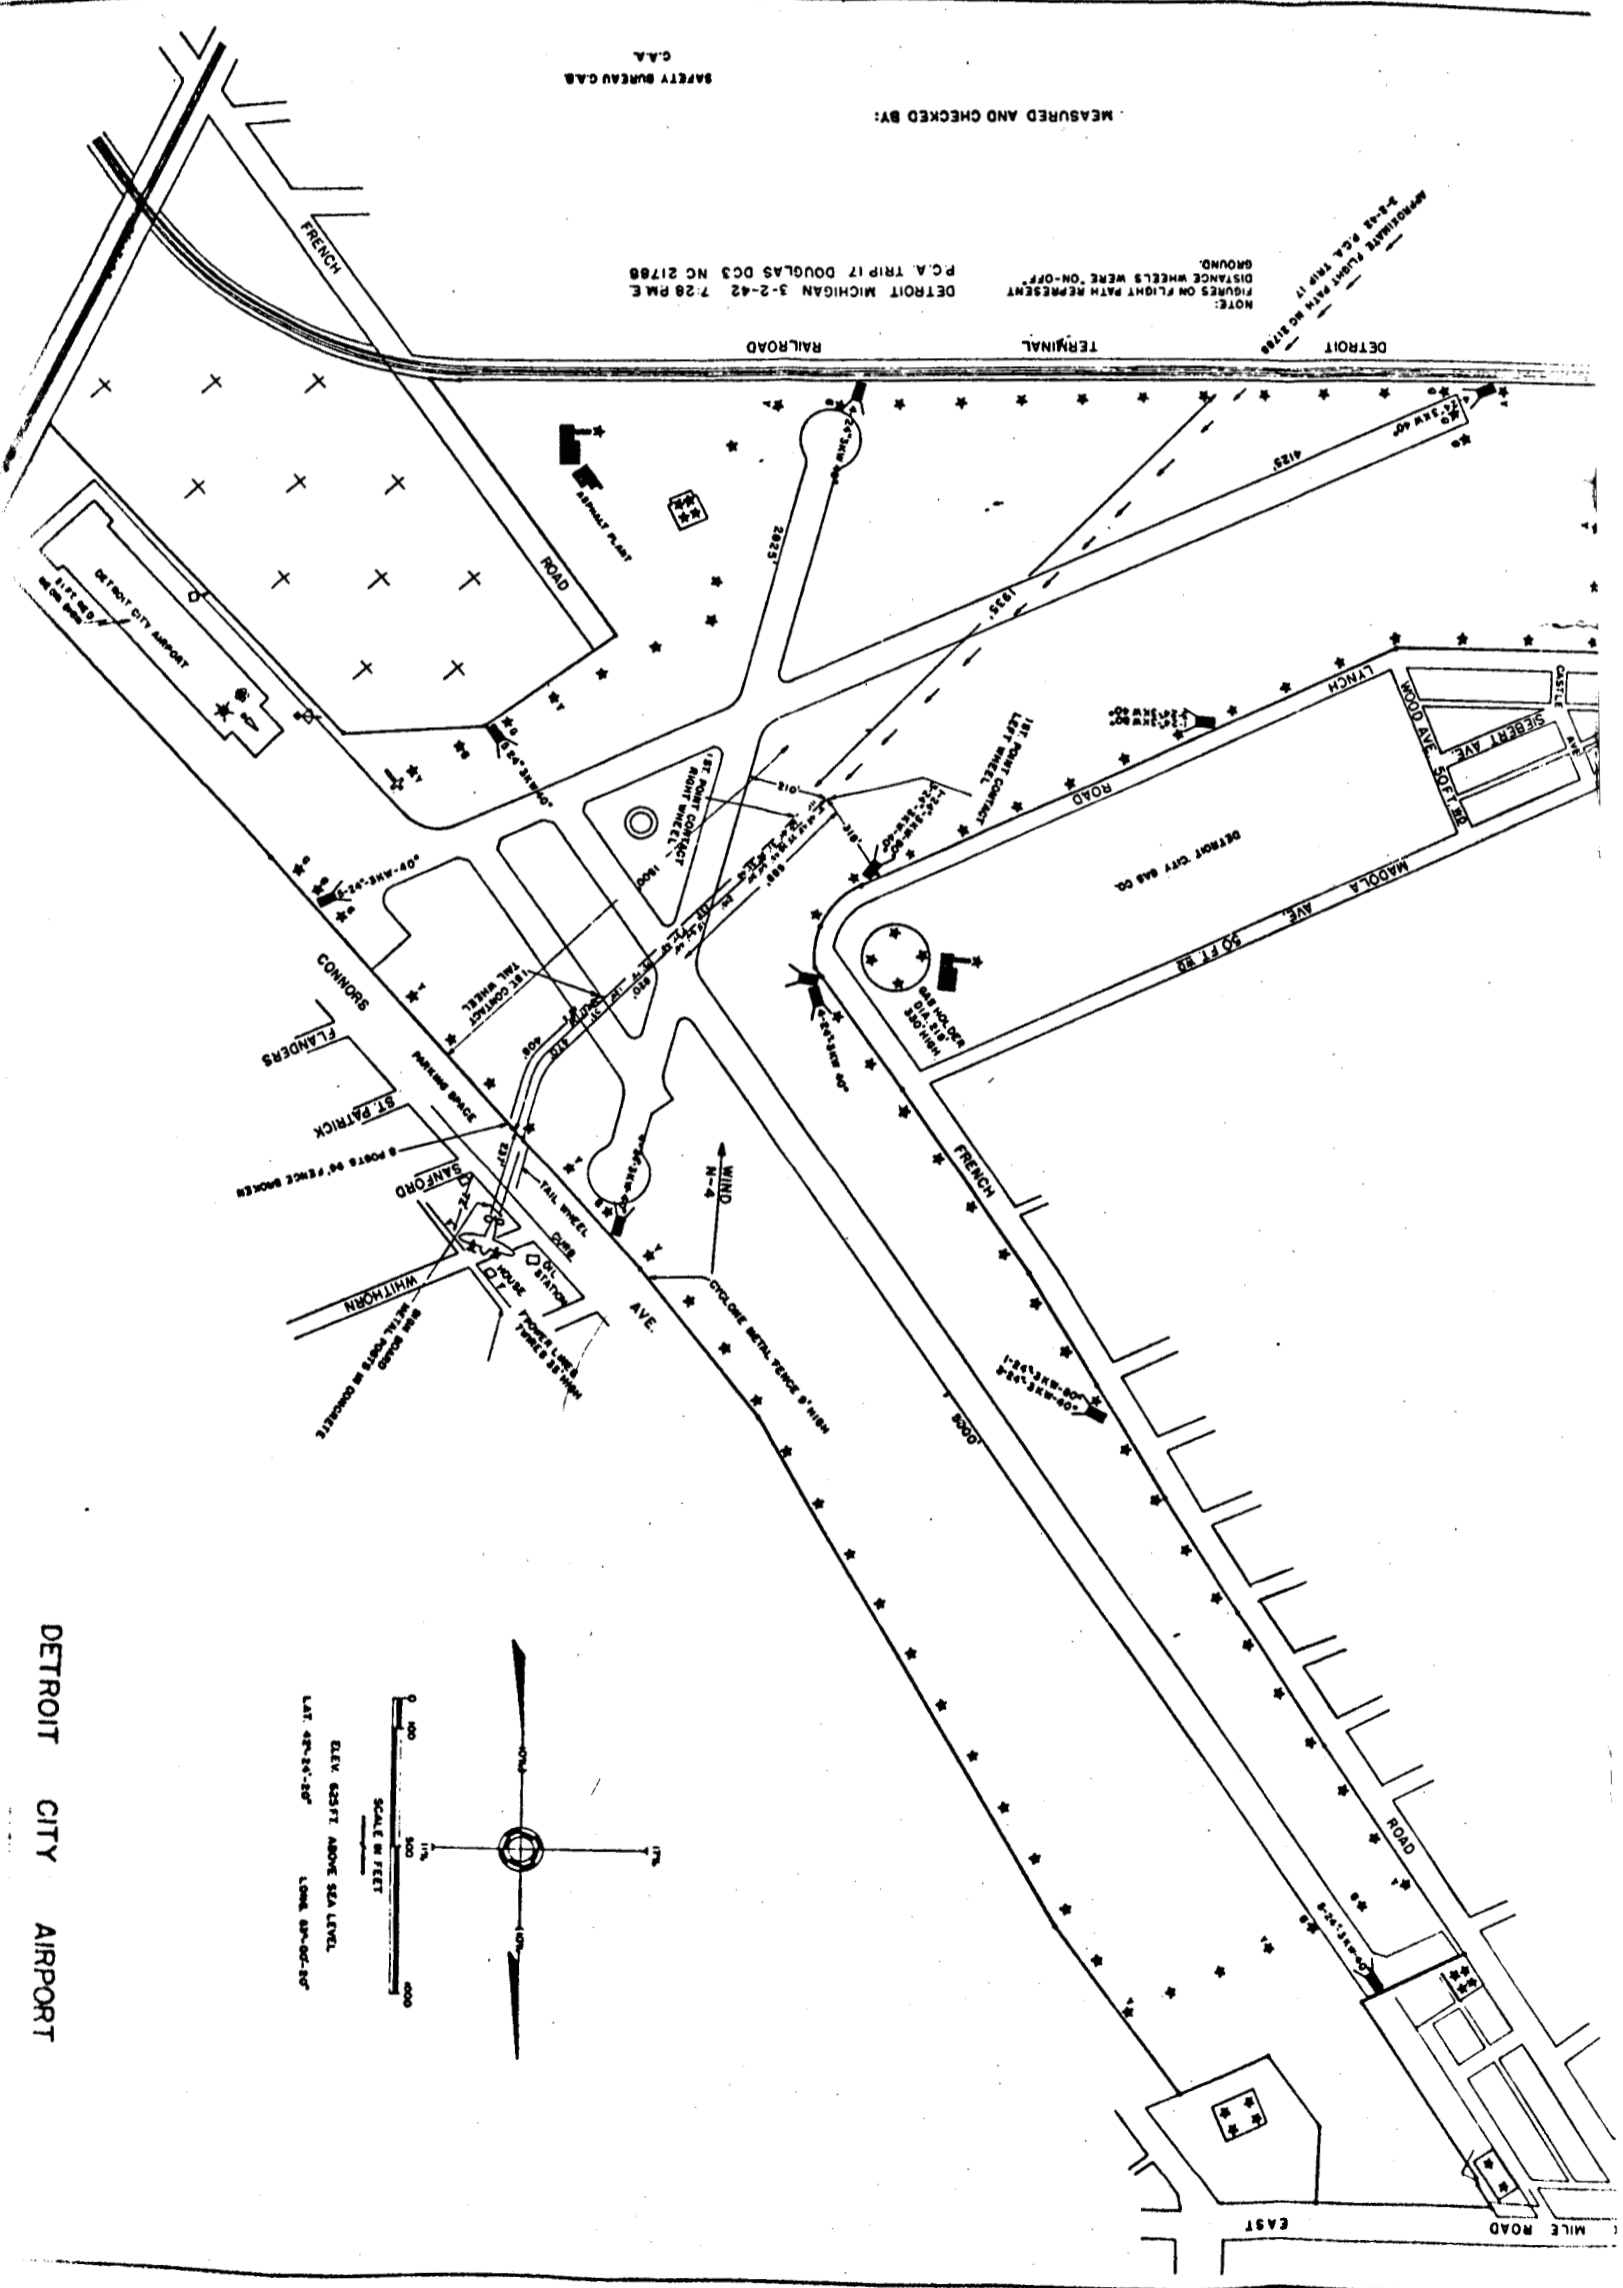
MEASURED AND CHECKED BY:
 DETROIT MICHIGAN 3-2-42 7:28 P.M.
 P.C.A. TRIP 17 DOUGLAS DC3 NC 21788
 NOTE: FIGURES ON FLIGHT PATH REPRESENT
 DISTANCE WHEELS WERE ON-OFF
 GROUND.
 MANEUVERING FLIGHT PATH NO. 21788
 DETROIT

The landing path selected by Captain Read was approximately 3350 feet long. According to Captain Read, he thought at the time that the airplane contacted the ground at an airspeed of approximately 75 m.p.h. after passing over about one-third of this landing path. Subsequent examination of the wheel tracks left in the snow revealed, however, that the aircraft passed over 1935 feet of the landing path before either wheel touched the ground. From the tracks in the snow it appeared that the left wheel first contacted the ground rather sharply for a distance of 57 feet. This wheel then left the ground for 45 feet. Both wheels then made contact almost simultaneously, the left one staying on the ground for a distance of 48 feet and the right one for a distance of 60 feet. The wheels continued to leave the ground intermittently for a considerable distance before both of them made continuous contact. The brakes were applied but had little effect because the surface of the airport was wet and covered with snow.

of the aircraft, Captain Read was unable to turn sufficiently to avoid striking the fence. Wheel marks indicated that the left wheel had been continuously on the ground for only 820 feet, the right wheel for only 470 feet, and the tail wheel for only 408 feet, when the aircraft struck the fence. The airplane went through the fence at a speed of from 20 to 30 m.p.h., and continued for 237 feet across a street and into a yard before it finally came to rest. This occurred at approximately 7:28 p.m.
