File No. 722-42

Docket No. SA-59

REPORT OF THE CIVIL AERONAUTICS BOARD

On the investigation of an accident involving aircraft of United States registry NC 21788 which occurred at Detroit City Airport, Detroit, Michigan, on March 2, 1942.

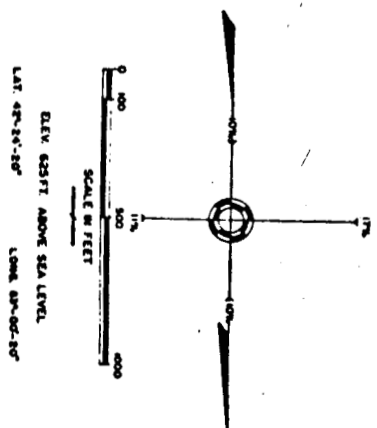
DETROIT CITY AIRPORT

MEASURED AND CHECKED BY:
 DETROIT MICHIGAN 3-2-42 7:28 P.M.
 P.C.A. TRIP 17 DOUGLAS DC3 NC 21788
 NOTE: FIGURES ON FLIGHT PATH REPRESENT
 DISTANCE WHEELS WERE ON-OFF
 GROUND.
 MANEUVERING FLIGHT PATH NO. 21788
 DETROIT
